# British Columbia Multihull Society

September 2021

## Boat Slaves

Rae Simpson August 2021

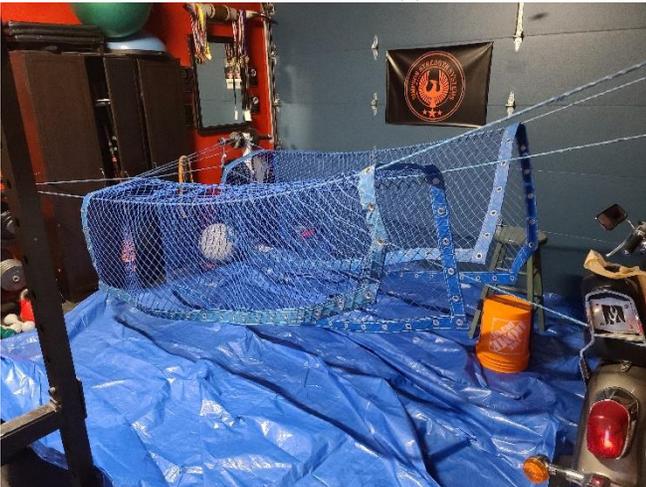
Fresh Blue Latex Applied

First up was an R&R on the tramp. Early spring my partner Sharon and I removed it, repainted it with a nice bright blue latex. Replaced all the slides and a few of the rivets. Then re-installed, trying out some slippery new dyneema line. Each side is one continuous line. Looking much refreshed and much safer.

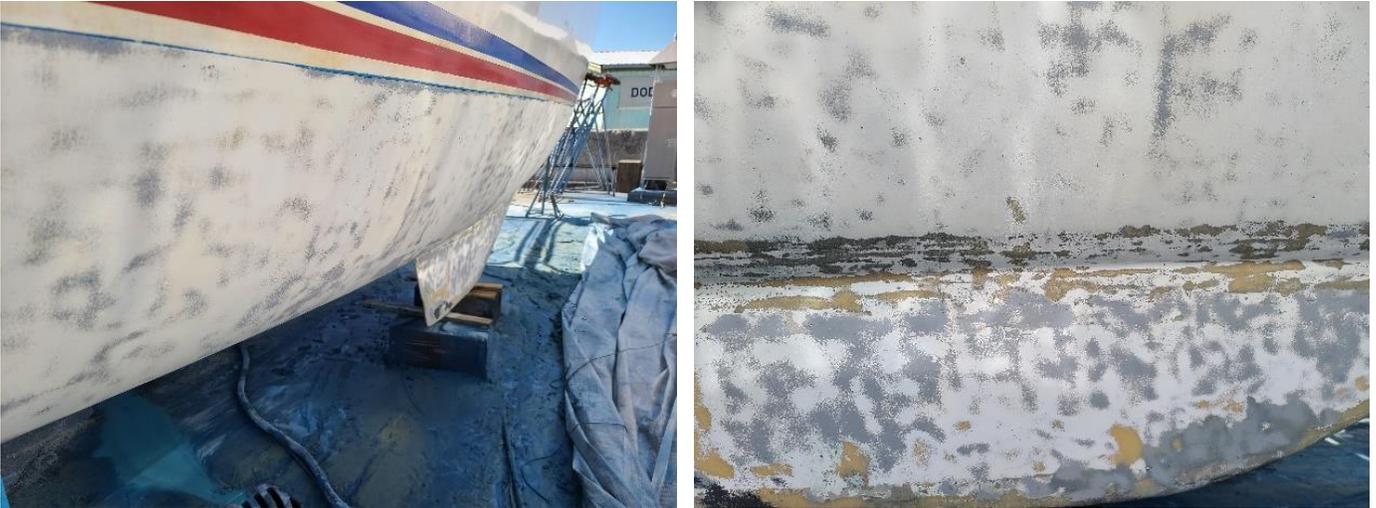
## After the Blast

Sanding old bottom paint is my favorite activity – said nobody ever! I read about a soda blasting technique which media from the eastern USA were raving. Seemed a good idea and an escape from sanding. I just had to throw money at it and presto bottom paint gone. Somehow between Marine Blast and me - soda blast became sand blast. That stripped the bottom paint off just fine. Along with the bottom paint came 90% of the previous barrier coat and 20% of the gelcoat. Did I mention the hundred or so tiny holes in the gelcoat?

It was nothing to do with the blast but, a half dozen blisters at the secondary joint where the mini-keels joined the hull emerged. These swelled up as the sun heated the hulls but were otherwise invisible. The hulls are vacuum bagged closed cell foam so a little water won't hurt them. It seemed like the resin did not get sucked into 100% of the gaps in the foam, then - over time, water wormed its way in to a few of those gaps.

Ok, head down, get going, grind or drill, mix and fill, sand and fair. Repeat ad nauseum. Half a dozen of the small gelcoat holes leaked a stinky clear fluid. These were flared out, dried out, filled and faired. The big blisters were ground out, vacuumed, dried out, filled with epoxy, and faired. Respect to Ron Tomas who helped with materials, tools, and technical advice.

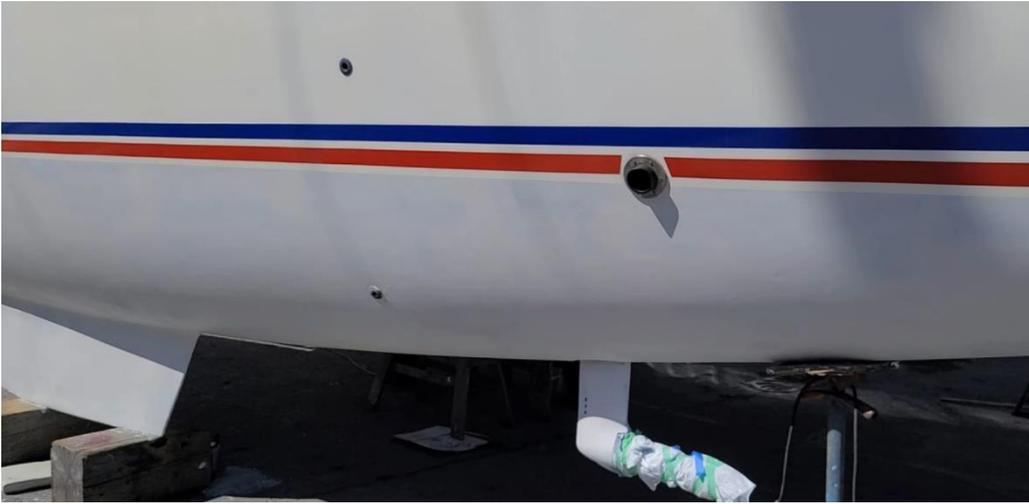
### New Stripes and the Fifth Barrier Coat

In parallel with the floorboards and dodger work, we used stripe remover wheels to lift the scratched up and faded old lower vinyl hull stripes. We laid down fresh bright red and blue stripes. Under those stripes, we put on a total of five Interprotect epoxy barrier coats. Those will seal the hull watertight for the next 20 years or so. We also changed the oil in the legs, replaced all zincs, inspected the rudder shafts and the obligatory topside wash and wax. Back in the water – our two weeks haul out lasted 6 weeks.

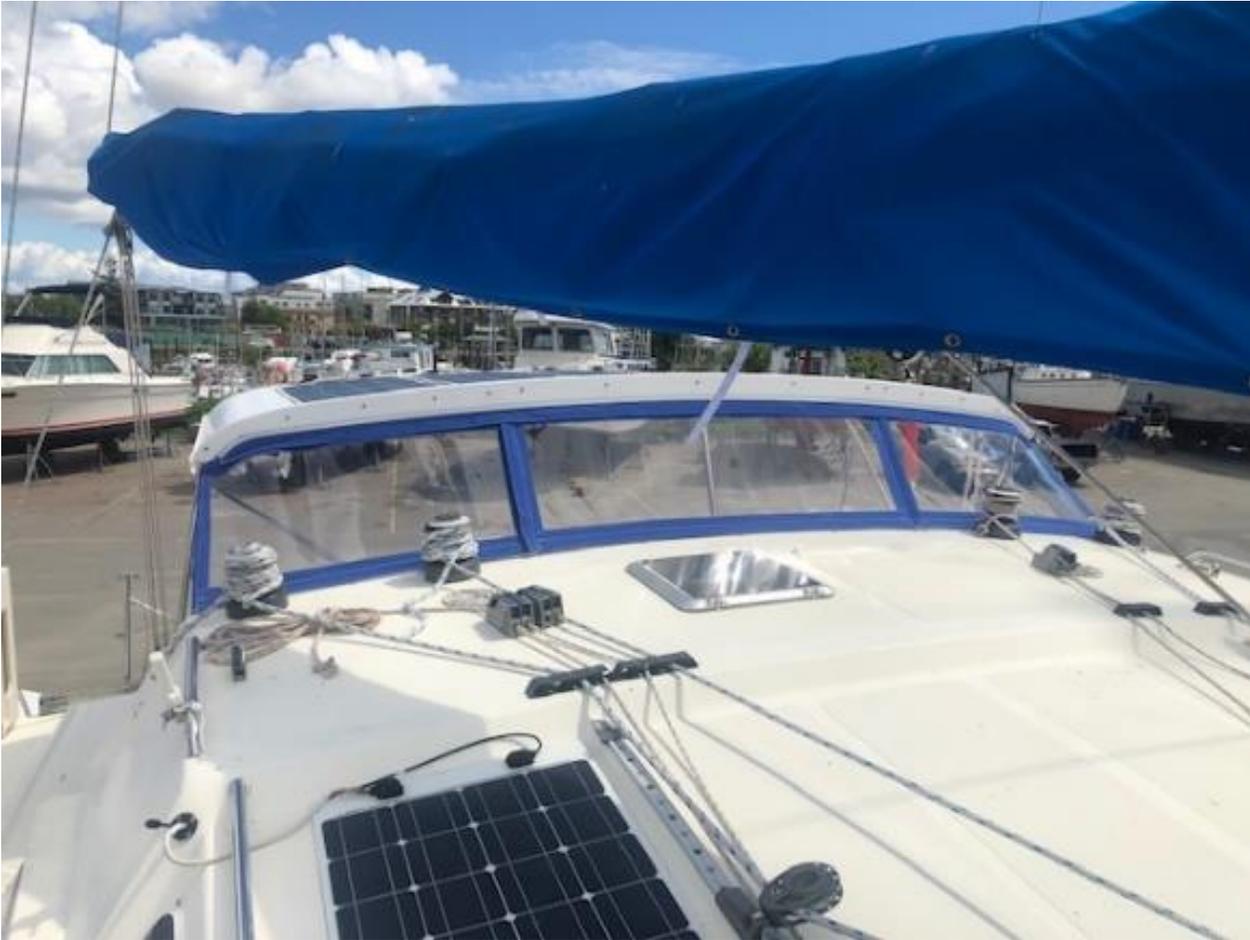
## Professionally Built Dodger

We had installed a hard top, built by Tim Poustie a year or two back, and did a quick and dirty job adapting the old dodger to the new hardtop. Over the winter Sharon tried to modify the old dodger to fit properly. I thought it was fine – but Sharon was just not happy with the results. Lucky for us, Master Craft Boat Coverings' shop was right next door to the boat. Frank managed to build an awesome new dodger for us within our steadily lengthening time at Strait Marine.

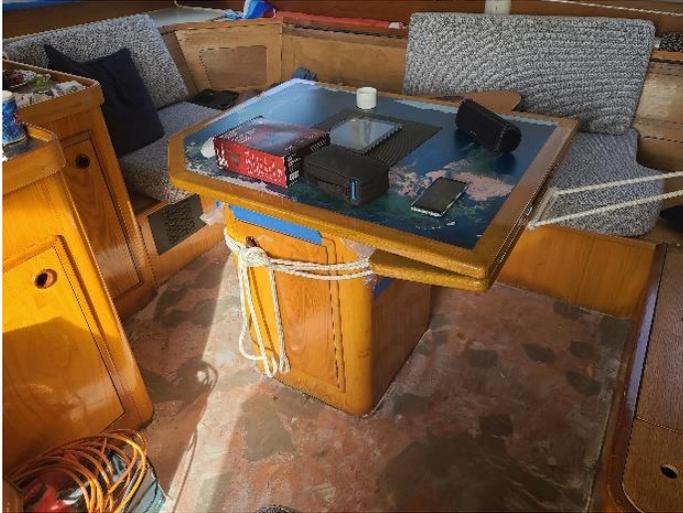
Ugly Salon Floor

Just enough time to sail back across the Salish Sea to our Ladysmith Raven Point marina to strip the old floor tiles out of the salon then sail the boat down to Canoe Cove for our appointment with 3C Yacht Services. 3C had agreed to install the replacement faux mahogany and holly vinyl floor from Plasteak. Buggars! After specifying an epoxy filler for floor fairing, the turkey's used a zinc based product that dissolved in water! I've experience with that product, and it turns to mush in high humidity situations in a year or two. No amount of persuading and showing them the manufactures spec's could make them redo it right. Reluctantly I stopped

work. We headed back our Raven Point moorage with a disgustingly ugly plywood and resin floor covered with a poorly installed water-soluble filler and a bad taste in our mouths.

Back at our marina (Raven Point in Ladysmith) we met an enterprising young couple who had moved west from Quebec. Stefane has lots of floor installation expertise and agreed to correct 3C's errors and complete the floor installation. His work was outstanding.

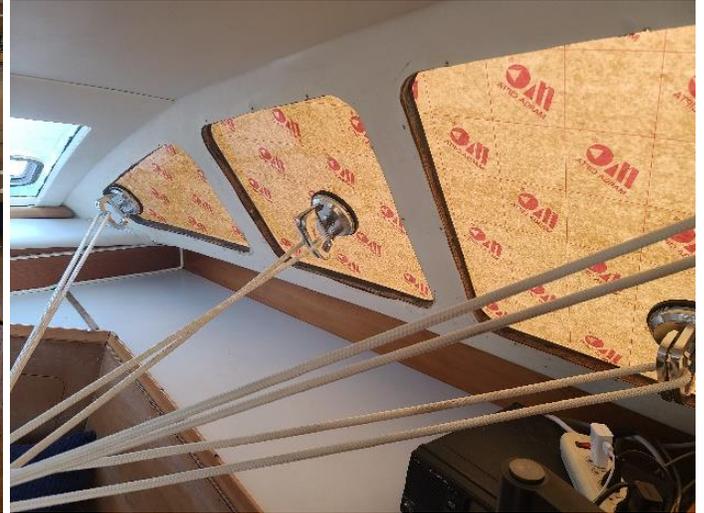
Window Tricks

Our salon windows were crazed from the sun and showing spots and scratches - 32 years of use, much of that in the tropics. Last fall (2020), I lined up Plexi-Klass of Victoria to supply and cut the acrylic glass windows, but the rains had begun so we delayed to this spring. Then COVID travel restriction made our supplier inaccessible. As soon as restrictions were eased, we shelved the floor project and tackled our windows. Vic at Plexi-Klass cut acrylic for the side and smaller front windows and hatches. He could heat and bend the small windows, but the big front window had compound curves that were beyond his capabilities.

4 of 5 windows new windows removed and re-installed. Arduous work. The Fein tool could break the old Sika bonds, but wedges, chisels and a machete were required to reach the bonds where the Fine tool couldn't reach. Then meticulously scrapping and cleaning the tenacious old Sika off by mechanical means.

To install the big, curved acrylic side windows we used ropes, weights, suction cups and Sika 295 UV (polyurethane) to glue and bend those windows to match the boat's curves. The ropes and weights were left on for 3 weeks to ensure the curves in the acrylic were permanent.

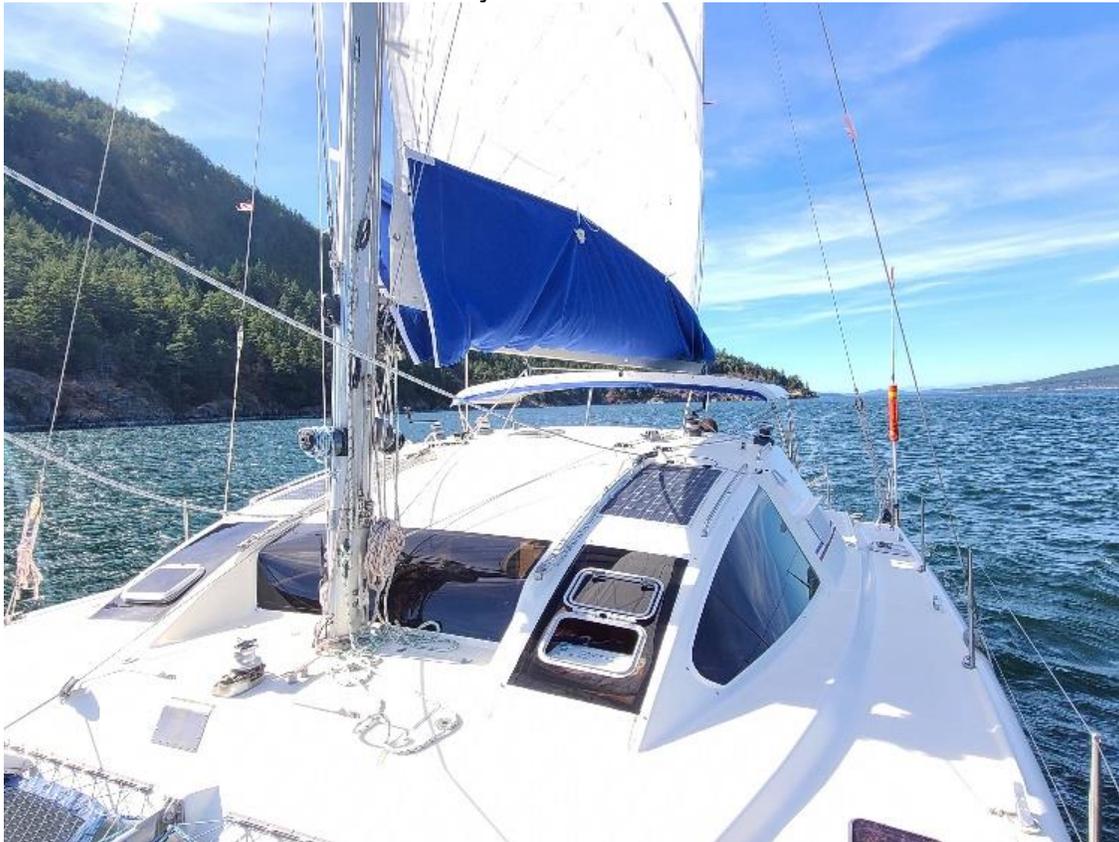
### Sexy New Windows

Finally, we get the call from Brian, the front window was now finished to his high standard. We brought it back and rough fitted it. Perfect. Awesome improvement over the old window. Brian eliminated the visual distortion at the major bend in the window. Of course, now the rain starts. A scramble ensued as we rushed to catch the drips and slow the leaks from the unsealed window. The next day, too much wind to primer or safely maneuver the window. Day 3 installation went well.
